National Register of Historic Places Registration Form

1. Name of PropertyHistoric name: The Almshouse Farm at Machipongo (Update 2024)Other names/site number: Poor House, Parish of Hungars, The Barrier Islands CenterName of related multiple property listing: N/A

The Almshouse Farm at Machipongo (DHR ID 065-0053), located in Northampton County, Virginia, was originally listed in the National Register of Historic Places and the Virginia Landmarks Register in 2001. The original nomination form identified two areas of significance for the property: under Criterion A, Social History, and under Criterion C, Architecture, with a period of significance of 1725-1952, encompassing the date of the earliest extant resource and ending with the property's cessation as an almshouse. The purpose of this Additional Documentation is to update the Almshouse Farm at Machipongo nomination to provide current information about the resources on the property, including their physical condition, and to provide further support for the significance of the property.

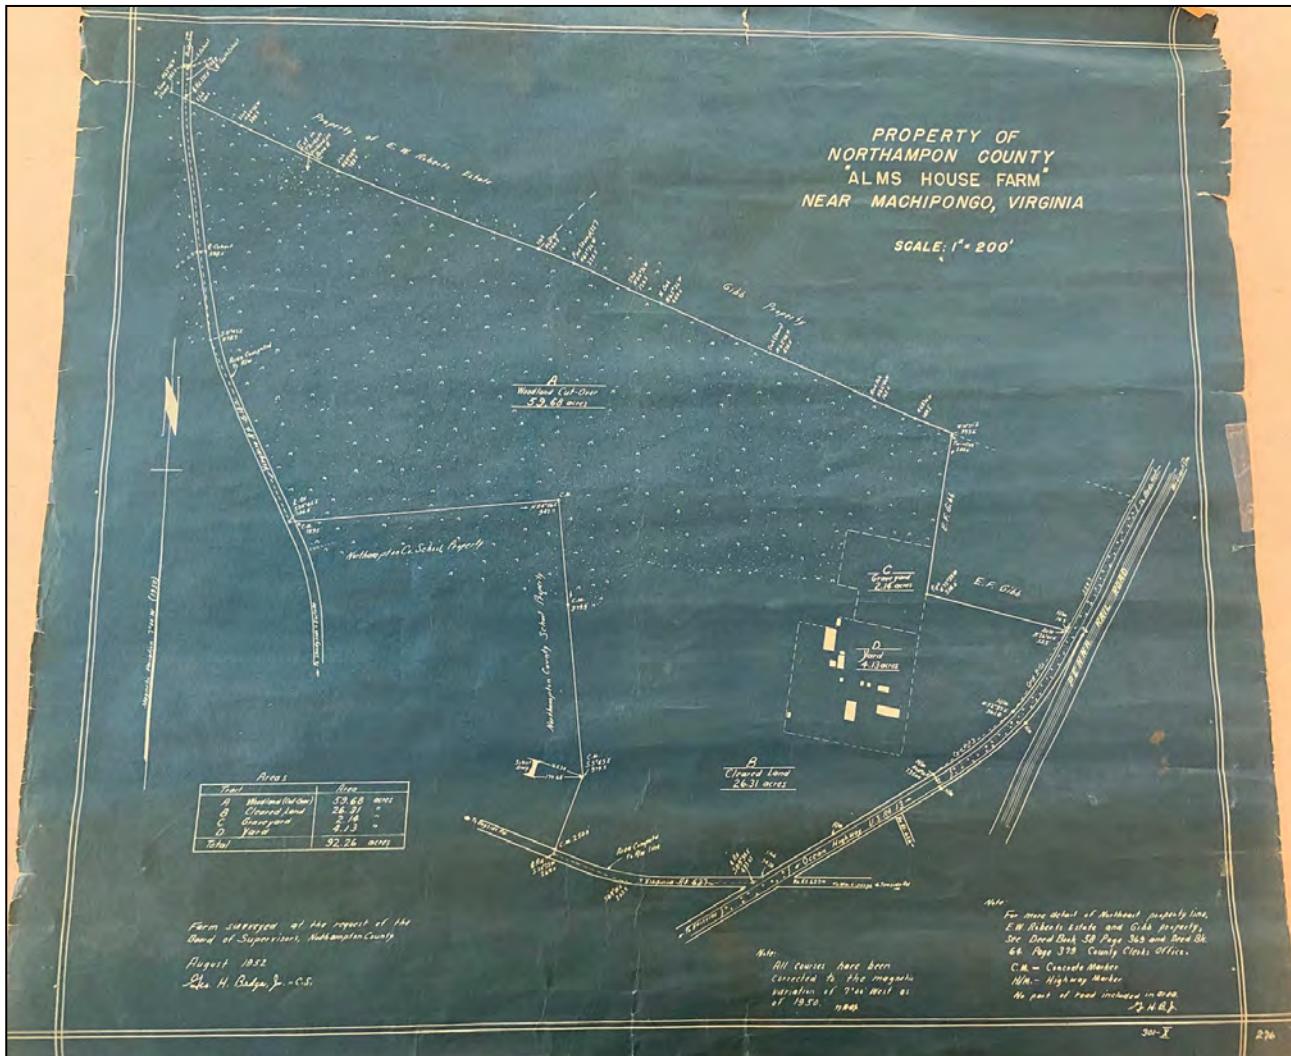
Figure 1: 1952 Land Survey Blueprint of the Almshouse Farmland at Machipongo

²⁰ Board of Supervisors Minutes Information Packet, March 1914. NOTE: A second, better-documented cemetery historically was associated with the poor farm. It occupies a 2.14-acre site noted as the "Graveyard" on the 1952 land survey (Figure 2 above). As shown on this drawing, the approximate physical location of this cemetery is depicted north of the main 4.13-acre "yard" with the buildings. Today, the site is believed to be roughly located within the tree-filled area northwest of (beyond) the nominated boundary. The nominated boundary of the Almshouse Farm at Machipongo coincides with the property's present 17.89-acre parcel, while the cemetery became part of a different parcel when the former Almshouse Farm was subdivided in 2000. While the cemetery is not presently included within the nominated boundary, if the boundary were expanded in the future, this cemetery likely would be a contributing resource to the Almshouse Farm at Machipongo. Today, a wood cross at the edge of the tree line marks the cemetery site.

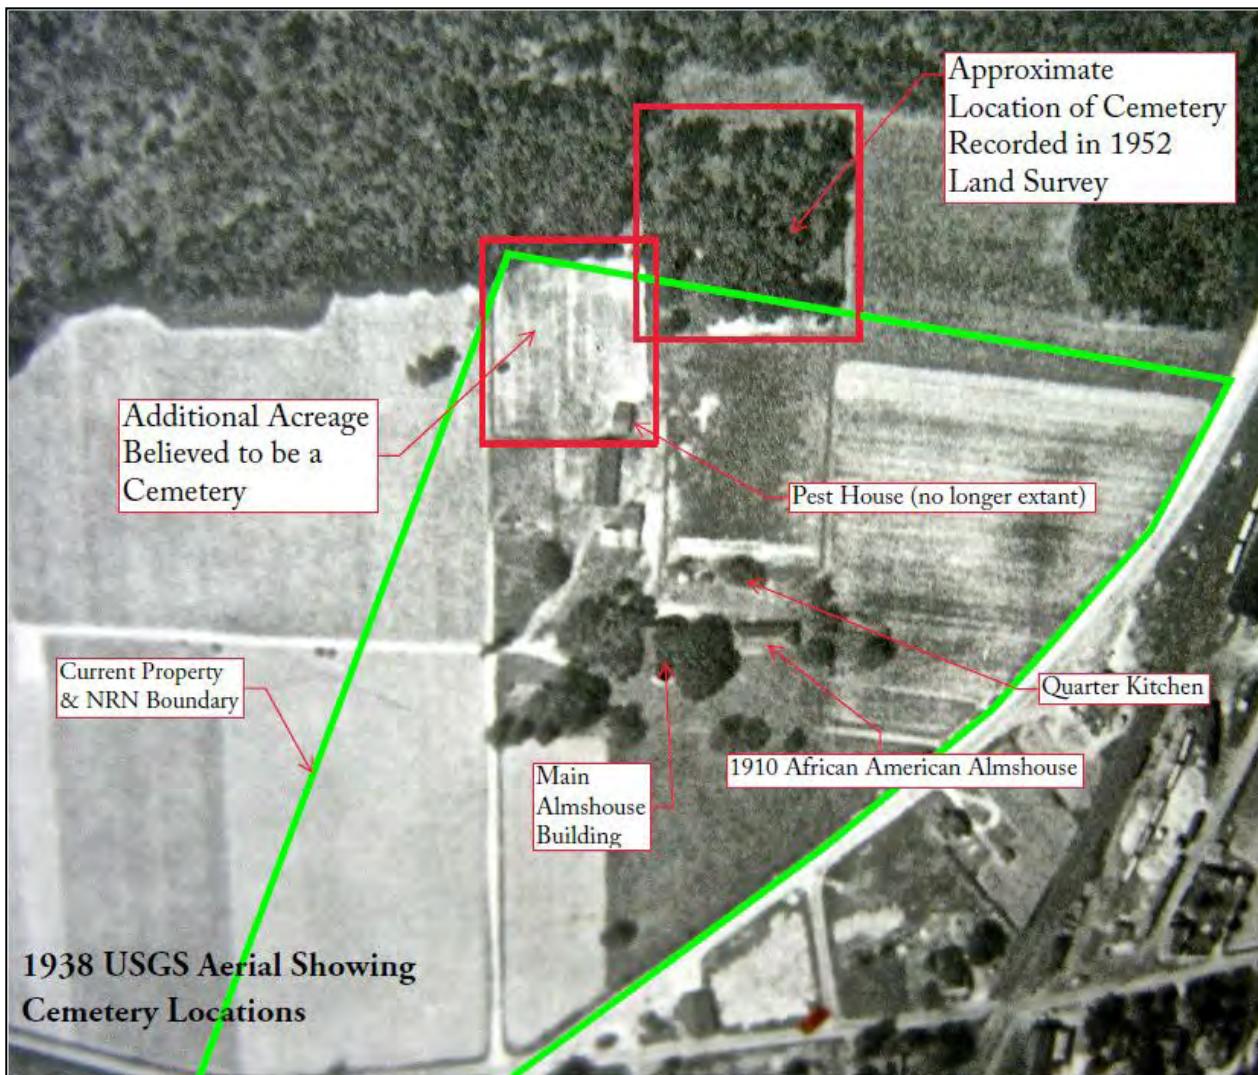
Figure 2: 1938 USGS Aerial Showing Cemetery Locations at the Almshouse Farm at Machipongo. The green line marks the nominated boundary. The red squares mark the approximate locations of each cemetery.
