PRELIMINARY INFORMATION FORM (PIF) for INDIVIDUAL PROPERTIES

DHR No. (to be completed by DHR staff) 095-0334

Property name: Bishop-Cole House

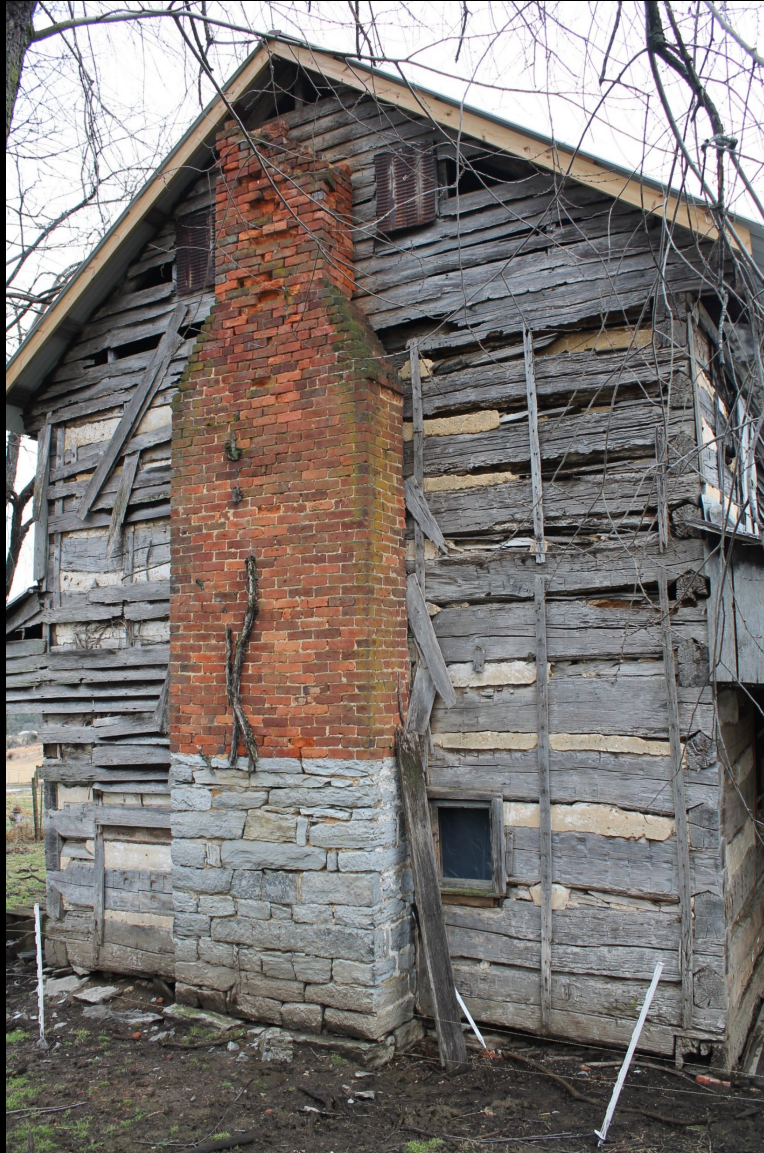
095-0334_BishopHouse_2018_S_elev_detail_03

The cut limestone foundation is below ground surface at the west end of the house, with the bottom log almost at grade. The roof is clad with V-crimp sheet metal. The gable ends feature raking, extremely narrow applied strips of dentil molding. The house has relatively small window apertures with six-over-six or two-over-two sash in generally poor condition. Across the full length of the back of the house was a c. 1960 one-story shed addition that included a kitchen, with a corrugated metal roof. By 2018 the addition had badly deteriorated and was removed.

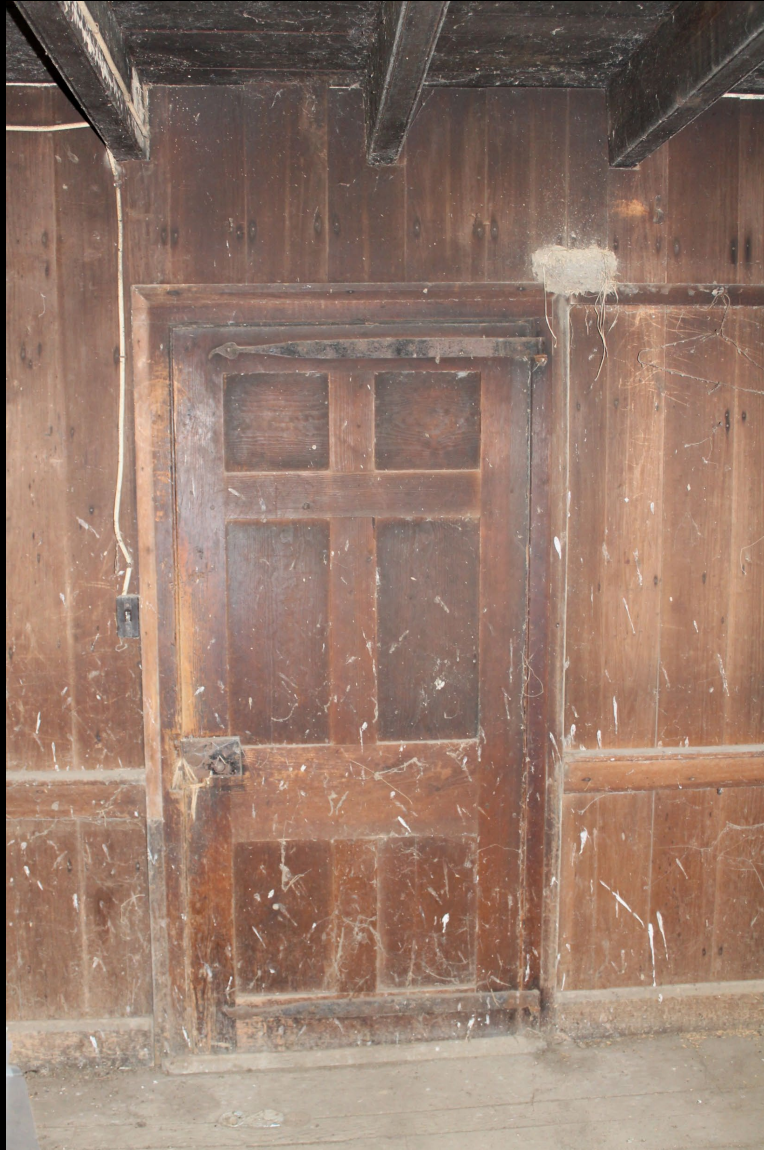
095-0334_BishopHouse_2018_front_detail

The house interior has a two-over-two room plan with six-panel front and back doors hung on hand-forged strap hinges. Other forged hardware, such as door latches, is also extant. The enclosed staircase is in the southwest corner. The enclosure is well-preserved, but the stairs themselves have badly deteriorated due to water infiltration, making second-floor access difficult. The first-floor fireplace, in the west wall, has the only mantel left in the house. It is a highly vernacular piece bearing no conventional style. The firebox has been refaced with brick. A chair rail is found on each wall of the room, the walls being finished with hand-planed vertically mounted boards. The second-floor joists and flooring are hand-planed and beaded, and bear traces of whitewash, as do the interior log walls, where exposed (chiefly on the second floor). Beaded floor joists typically indicate a pre-1840s date.

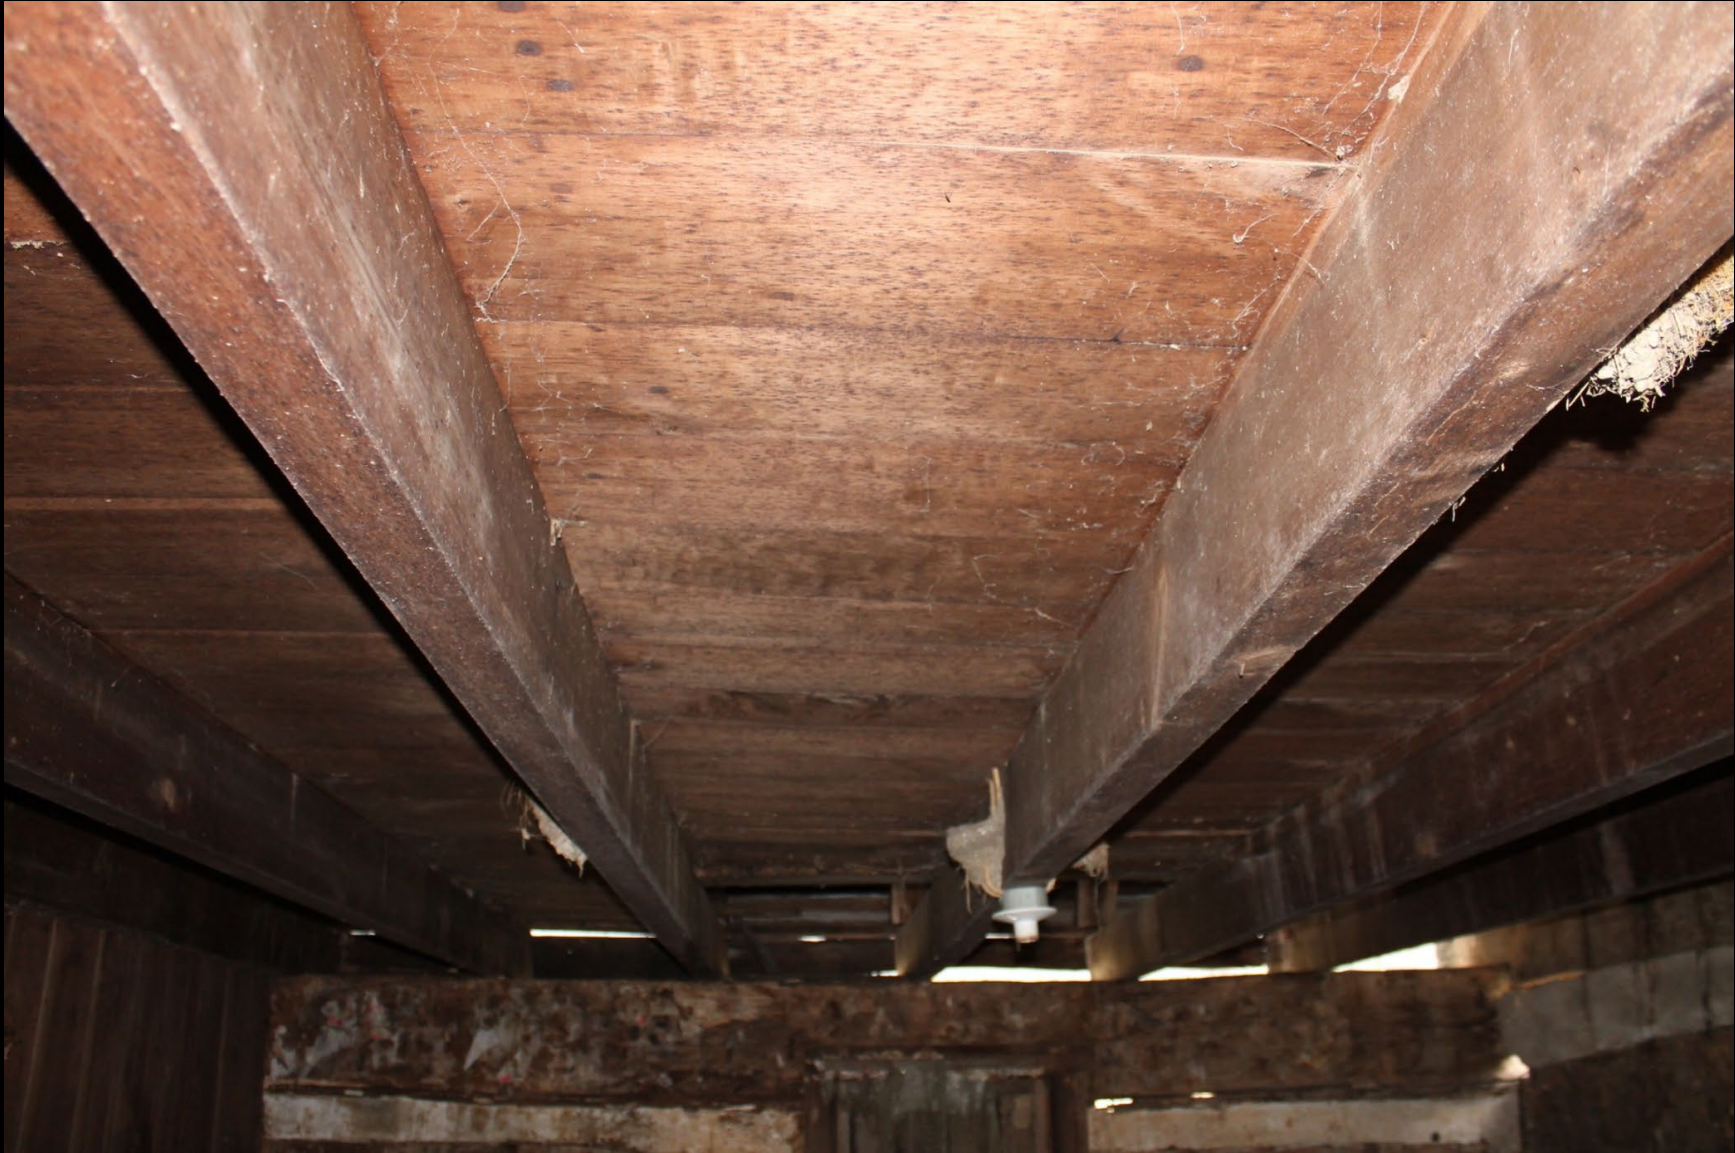
095-0334_BishopHouse_2018_2nd-flr_stair

Like the first floor, the second floor was divided into two rooms by a hand-planed vertical-board partition, leaving the east room unheated. The original stair rail, mortised into the floor, remains intact. The original roof rafters have been replaced with round poles nailed to a ridge board, but the wide, vertically sawn sheathing boards laid across the rafters, riddled with nail holes, are evidently original. The garret floor joists are planed but not beaded. All of the nails encountered throughout the house are mature machine-cut, which was the predominant nail type in use by around 1830.
